UTILISATION DU SYSTÈME D'ESTIMATION AUDATEX

MAZDA3

TEMPS DE REMPLACEMENT POUR UNE BIELLETTE DE DIRECTION INTÉRIEURE

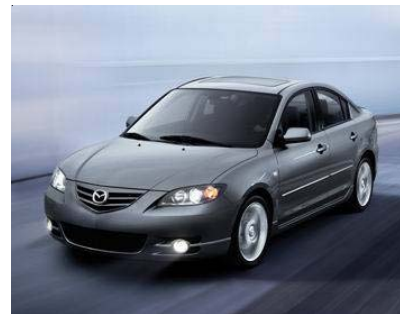
BIELLETTE DE DIRECTION
INTÉRIEURE

- Le système d'estimation Audatex semble générer un temps trop élevé pour le remplacement d'une biellette de direction intérieure et ce, peu importe l'année et l'édition de ce modèle.

RECOMMANDATION : Comme le temps de remplacement de cette pièce sur ce modèle serait, selon les informations obtenues, inférieur au temps généré par le système d'estimation, nous recommandons aux utilisateurs de vérifier auprès d'un concessionnaire le temps nécessaire pour procéder au remplacement de cette pièce et de procéder à la correction, si nécessaire, en effectuant une opération manuelle. Le problème a été rapporté à Audatex qui devrait éventuellement procéder aux modifications nécessaires, le cas échéant.

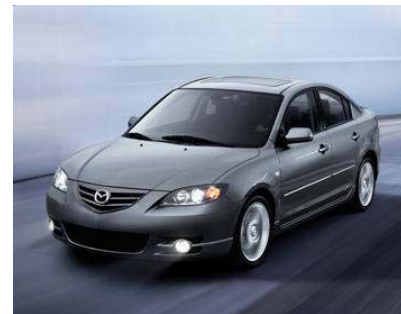
INNER TIE ROD

- The Audatex appraisal system appears to indicate too much time for the replacement of an inner tie rod, regardless of the year and model edition.

RECOMMENDATION: As the replacement time of this part for this model is apparently less, according to the information we have received, than the time indicated by the appraisal system, we recommend that users check with a dealer about the appropriate time required to replace this part and make any necessary correction manually. Audatex has been advised of the problem and should eventually make any necessary modifications.
